Sustainability of the Minor Irrigation Systems of the Cascades in Dry Zone of Sri Lanka: Challenges and Potentials

A Cultural Ecological Analysis

Nishan Sakalasooriya, PhD

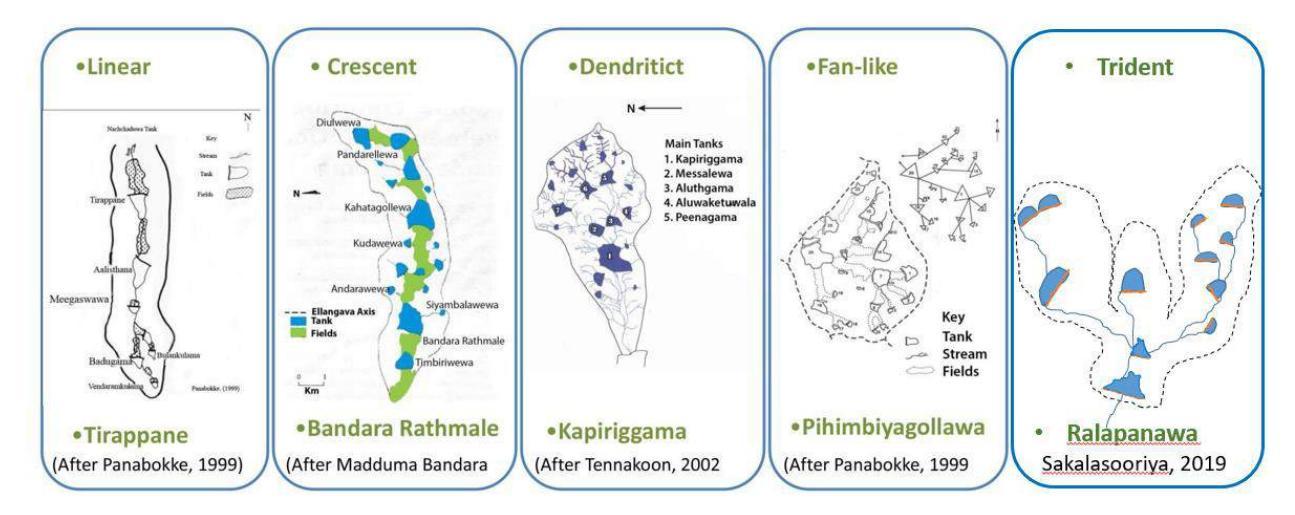
Figure 01 Types of Morphology of Cascade, Helmalu Wew Pokuru, Ellanga

According to the morphology, 05 types of Ellanga have been identified – linear, crescent-shaped, dendritic, fan-like, trident. Different shapes and morphology of the cascades have been visualized in Figure 01.

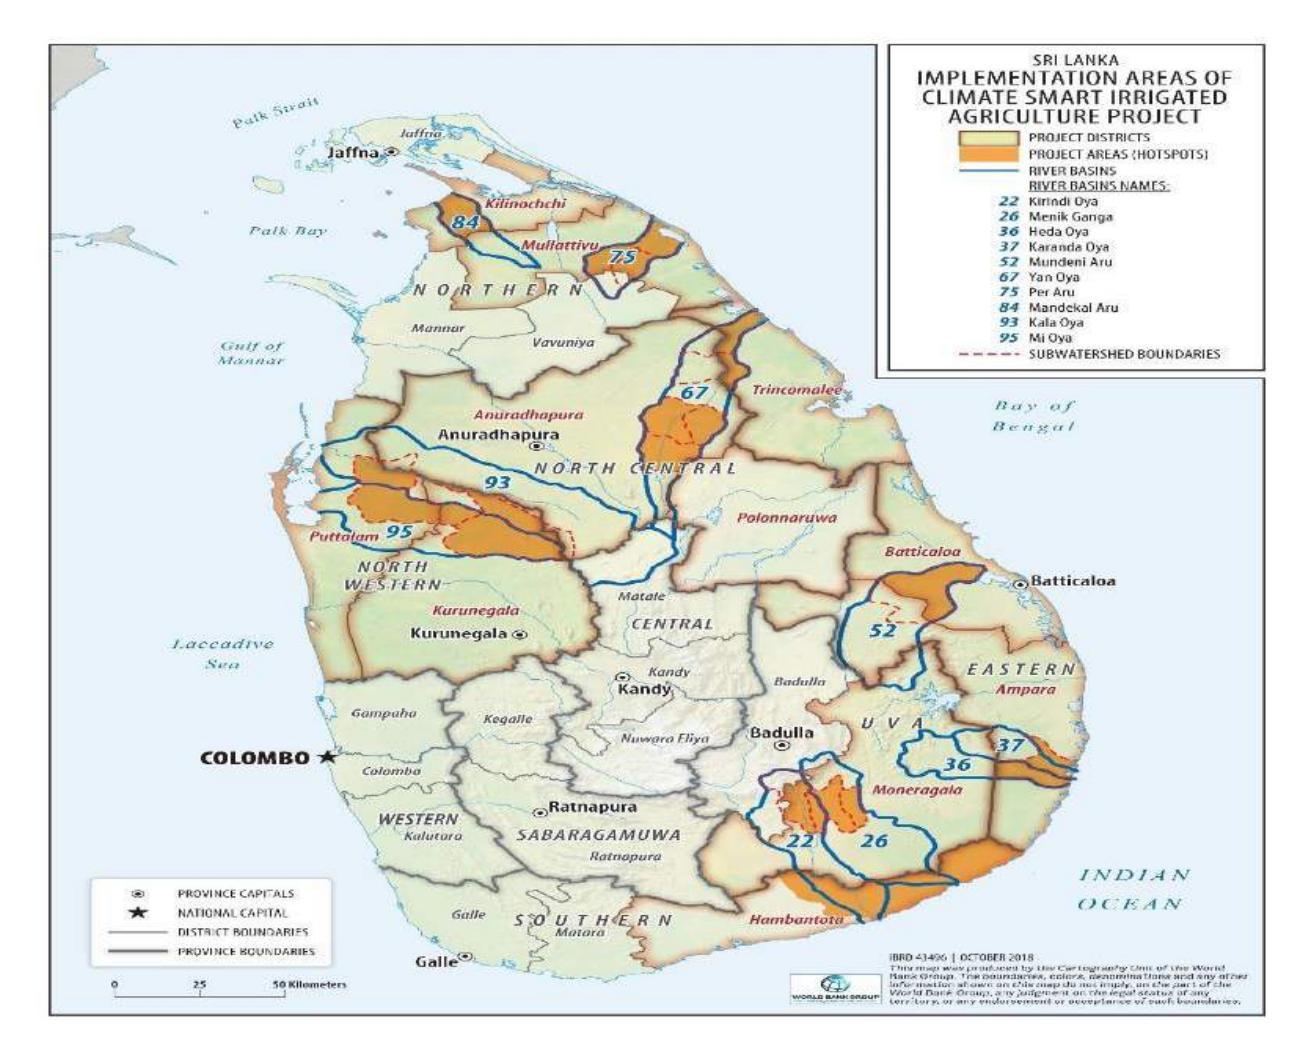
Figure 02 Respective river basins and identified Hotspot areas for the CSIAP project

The total identified area by the CSIAP covers nearly 375,000 ha of land in 12 river basins of Yan Oya, Heda Oya, Kala Oya, Kirindi Oya, Menik Ganga, Mandekal Aru, Per Aru, Mundeni Aru,

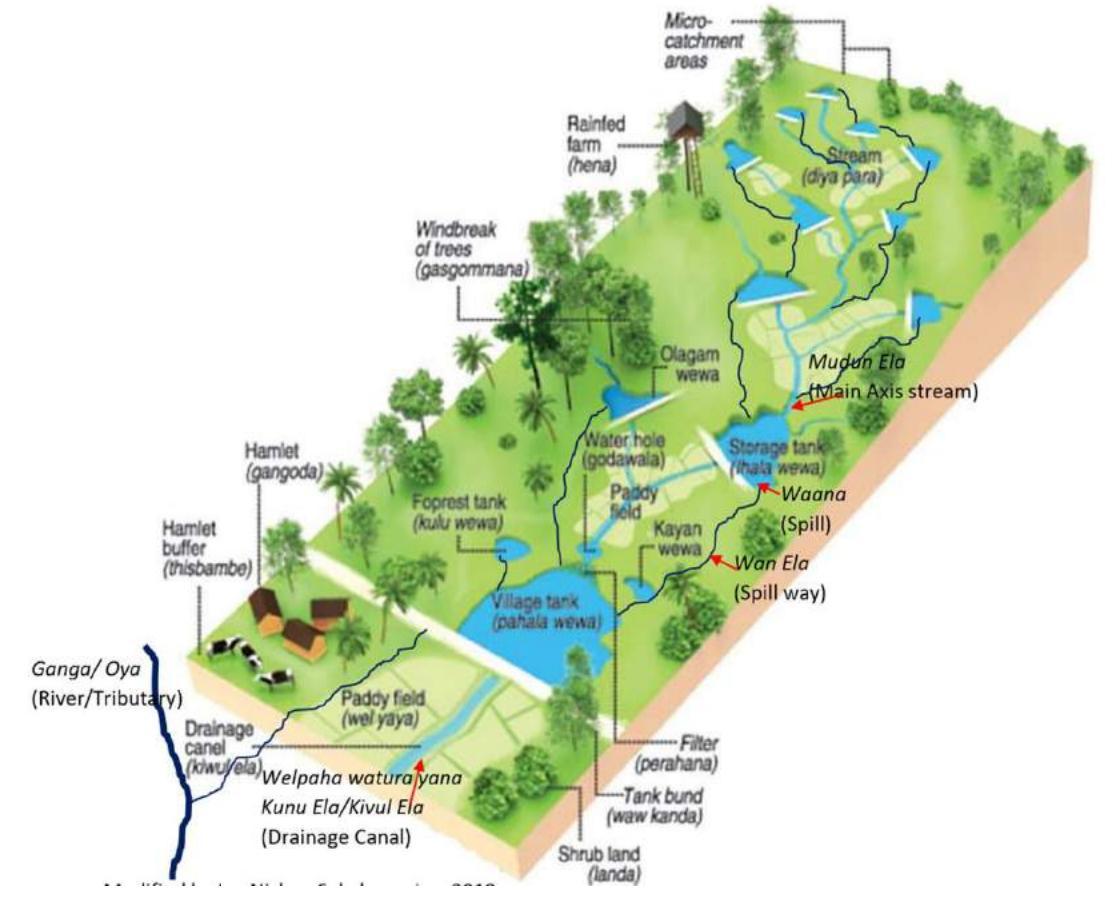
Figure 03; Major components of a Cascade, (Ellanga, Helmalu Wew Pokuru)

Figures 03 and 04 illustrate the geographic locations of different tanks in a cascade.

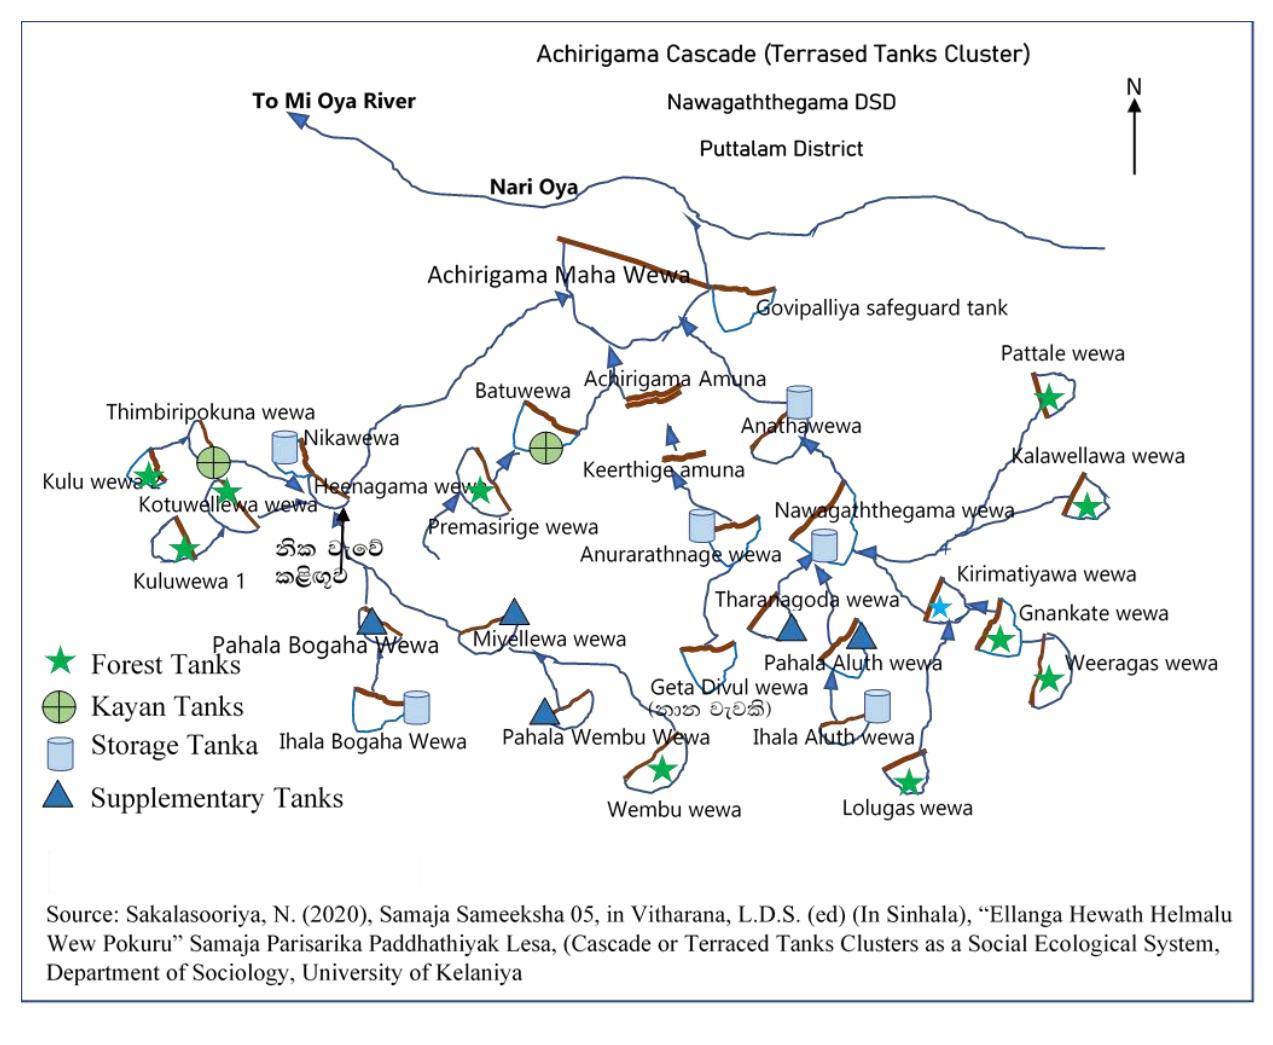
Figure 04; Different tanks of a Cascade; Archirigama Cascade in Puttalam District

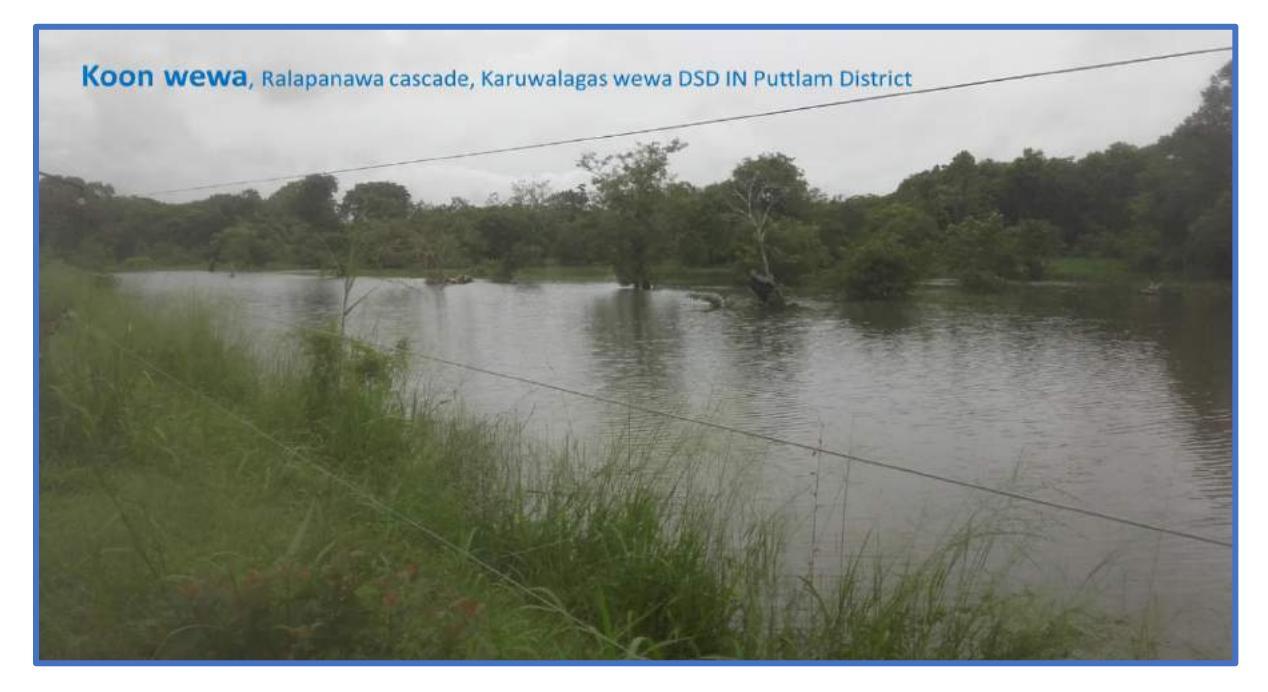
Figure 05, A forest Tank, *Kuluwewa*, Koon wewa, in Ralapanawa cascade, Karuwalagas Wewa DSD in Puttalam District

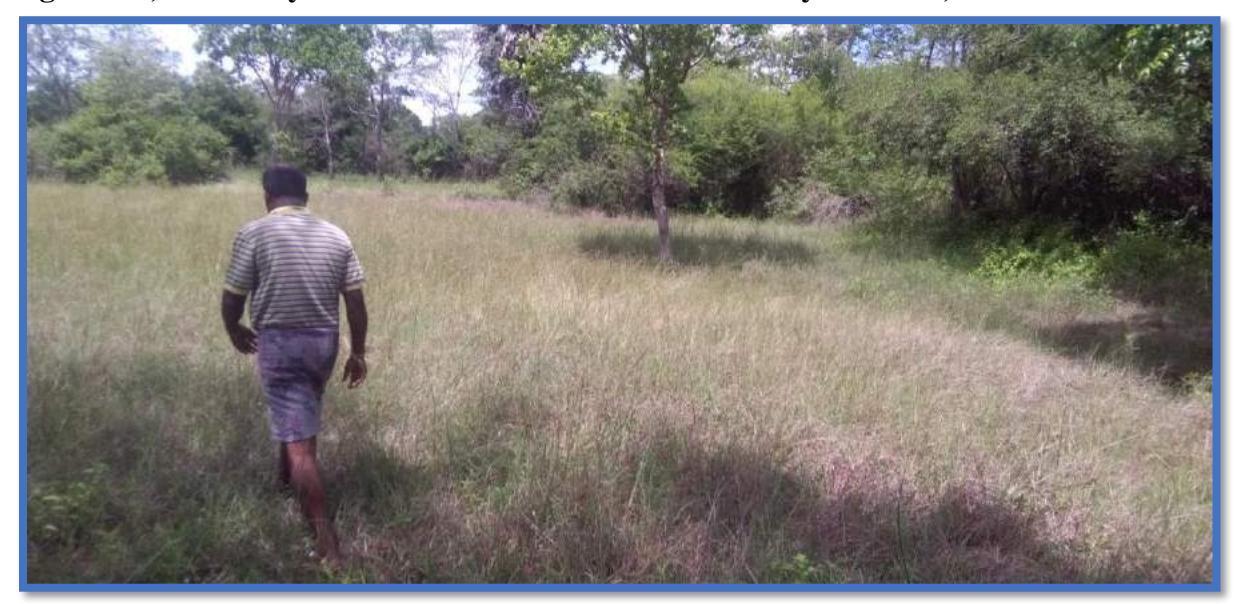
Figure 6, A Kayan Tank in Ihala Govi Palliya wewa, Rambewa cascade

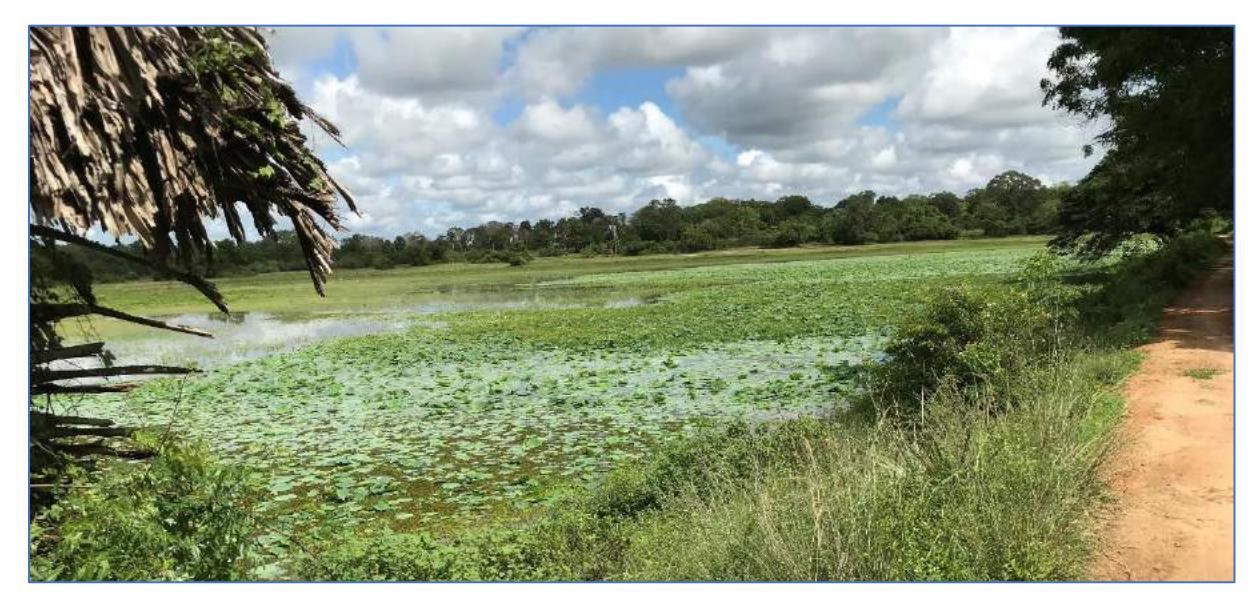
Figure 07, An Olagam Wewa, Ihala Dangas wewa in Rambawewa Cascade in Karuwalagaswewa DSD in Puttalam District

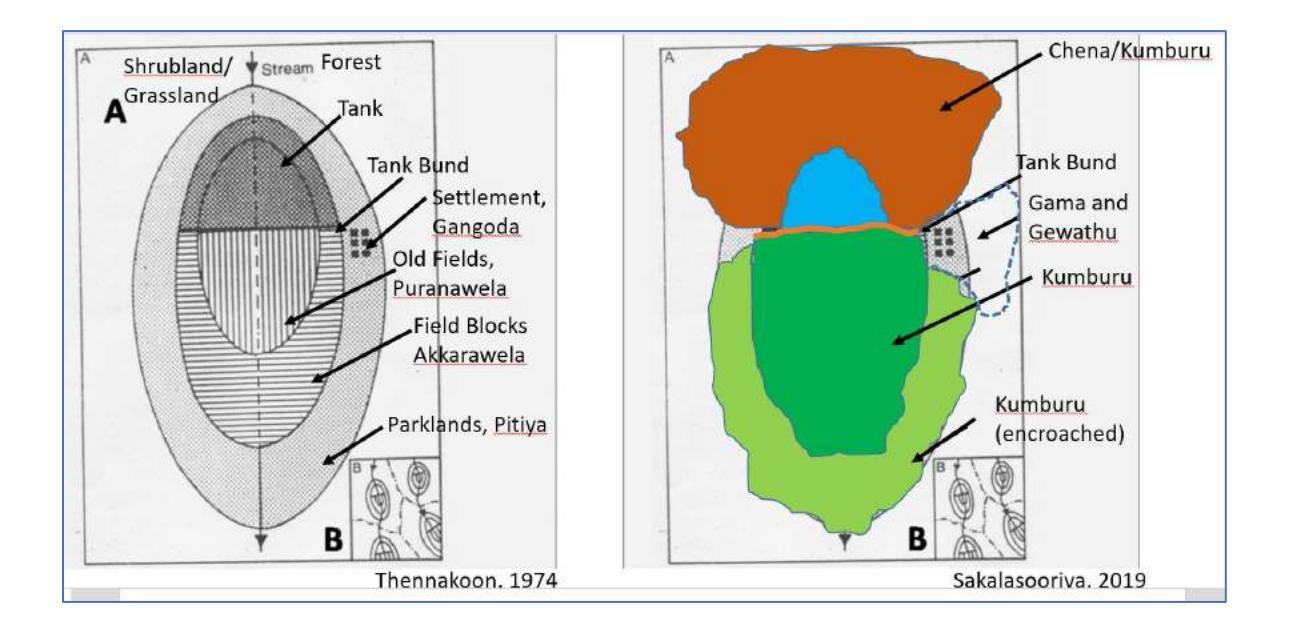
Figure 08, Old and new cultural ecological system of the cascades, Ellanga

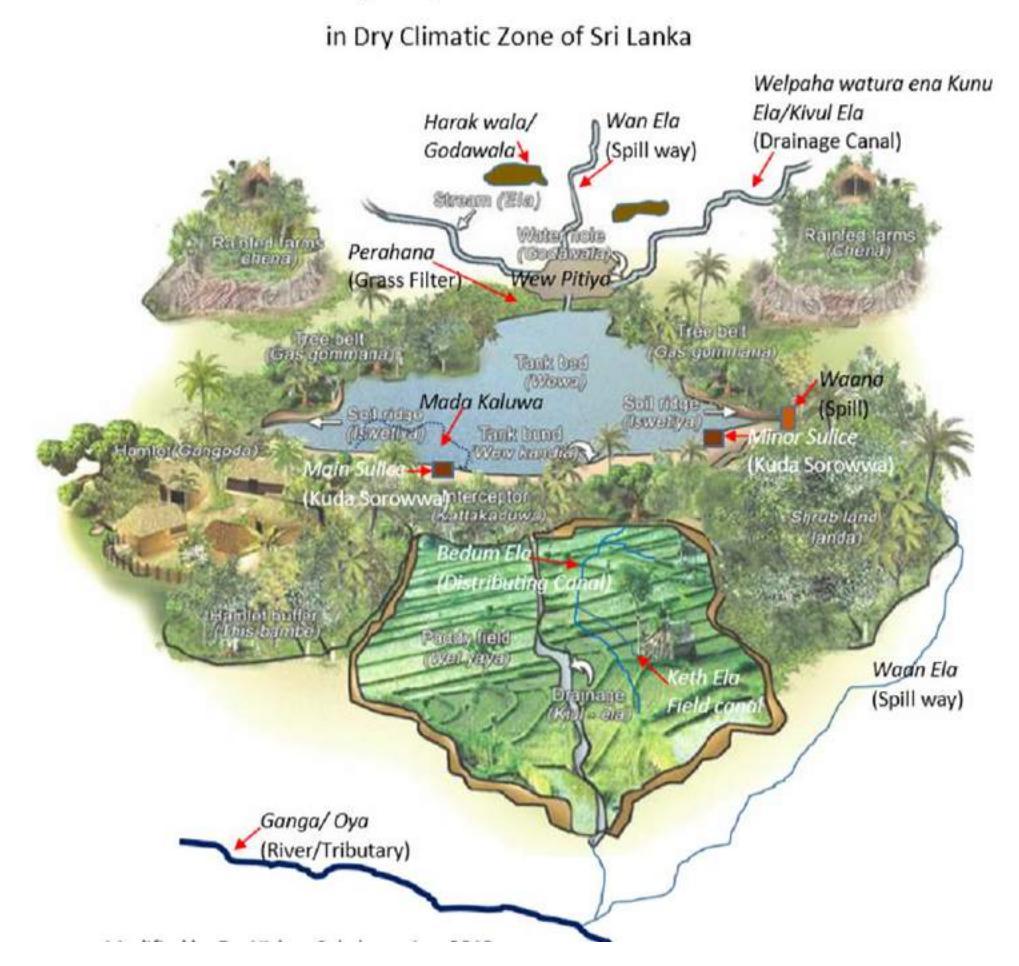
Figure 09, Main components of a traditional Tank Villages of a Cascade

Social-ecological system of a terraced Cluster Tank

- Tank bed
- Tank bund
- Upstream reservation
- Upstream water hole to trap sediment.
- Upstream earth ridges to prevent sediment inflow
- Downstream reservation
- Command area drainage
- Downstream sanitary cordon

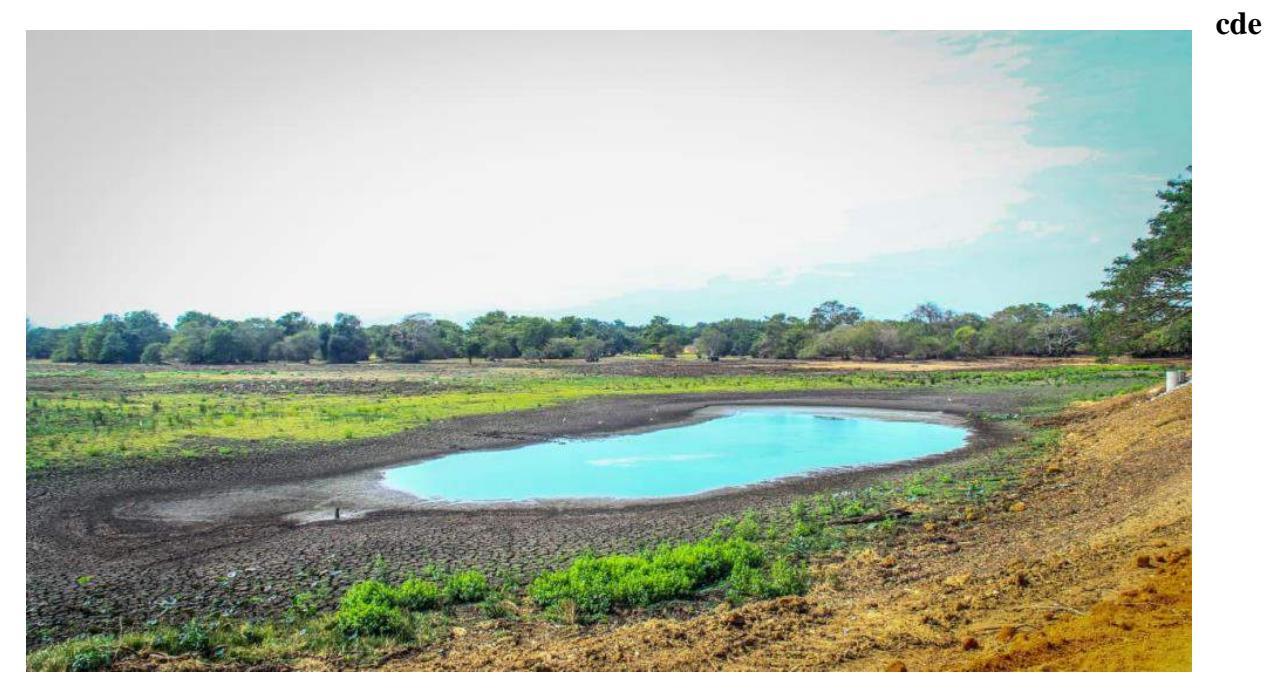
Figure 10, Dead storage phase (Mada Kaluwa) of Udakadawala Tank in Pulugaswewa Cas

The tank bed consists of four storing phases of water mass as dead storage, deep phase, shallow phase, and the high flood phase. Water in the dead storage cannot be used to irrigate paddy fields. When the tank gains its full supply level, this phase lies in the deepest water column. During the dry period, this small water body supports the surrounding vegetation by maintaining the groundwater level for the survival of the fish population, water for cattle, and even for wildlife.

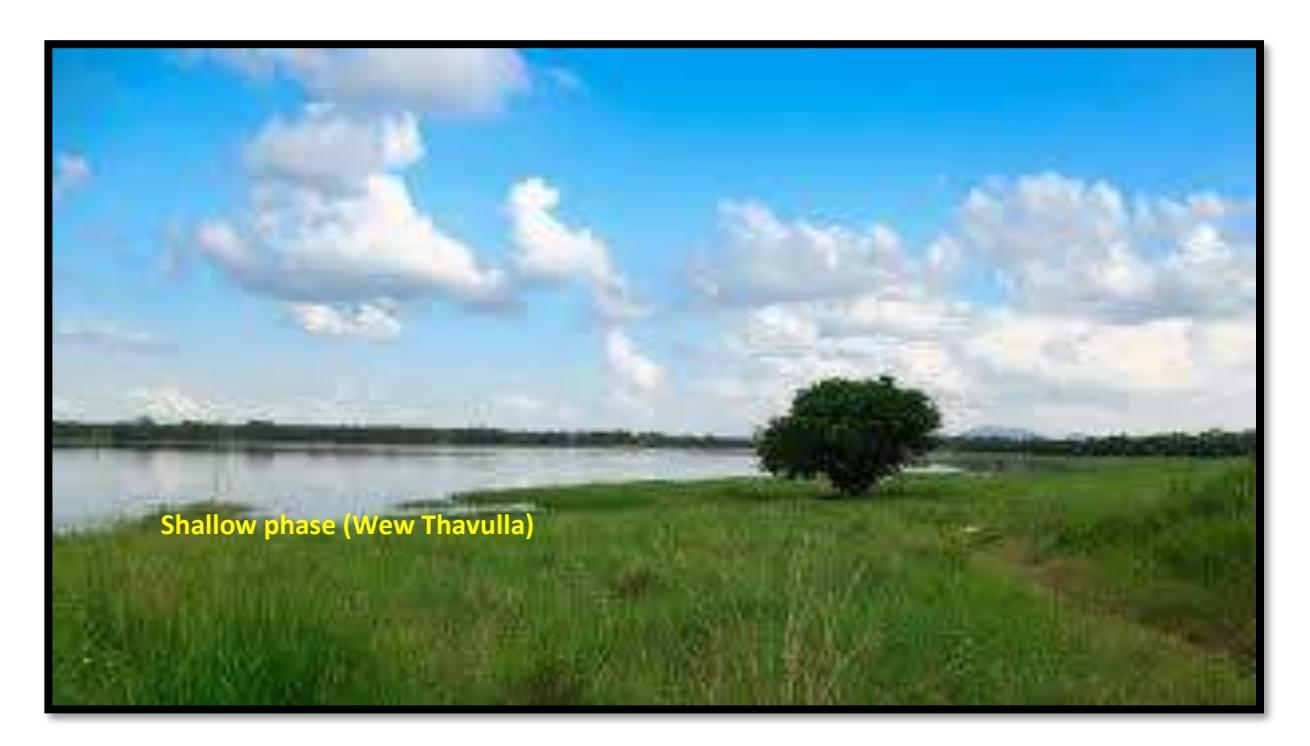
Figure 11, Shallow Phase, Wew Thavulla

Location: Palugaswewa, Palugaswewa Cascade, Habarana

This is the upper part of the tank bed. Water spreads as a shallow layer. Aquatic plants grow in this area. Birds roam in this area for catching fish. In the traditional system, people practiced tank bed cultivation (*Thavulu Govithena*) during low rainfall seasons by constructing a soil bund along the lower boundary of the shallow phase. When they needed to use the tank water for the Maha season, they used this water mass, which would anyway disappear during the first intermonsoon (January – March) period. Sediment removed is heaped up in this area making habitats for many birds — such as egrets, herons (*Koka*), jacanas (*Diyasaana*) and coots (*Kithala*) as well as for the other aquatic species. Swamp barb (*Puntius thermalis; Kota* pethiya), Tic tac-toe barb (*Pethia melanomaculata; Tithpethiya*), and juveniles of various Rasbora and Devario species are found in the water volume of the shallow phase.

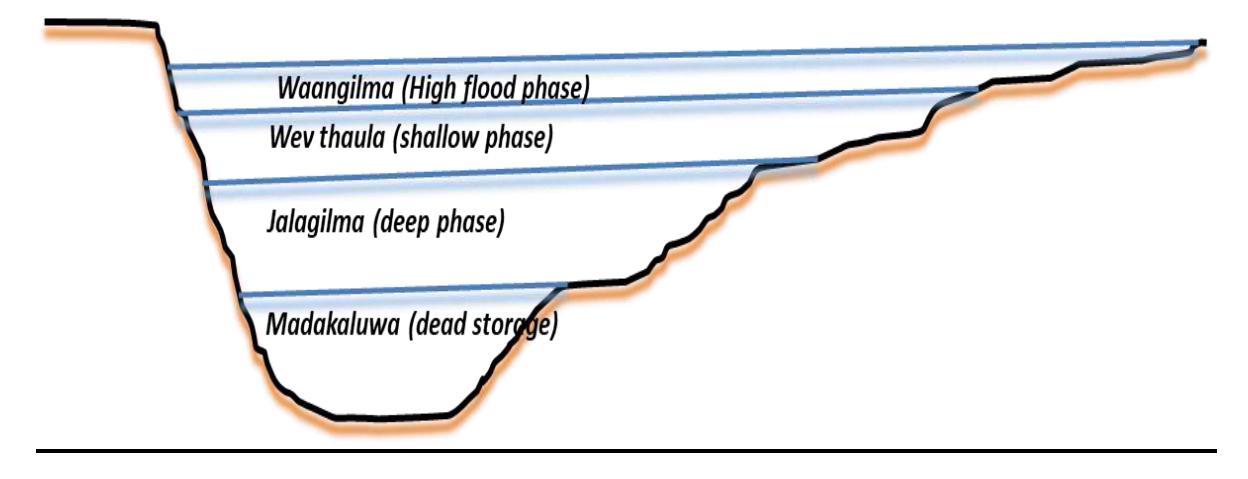
Figure 13; Four phases of the traditional tank

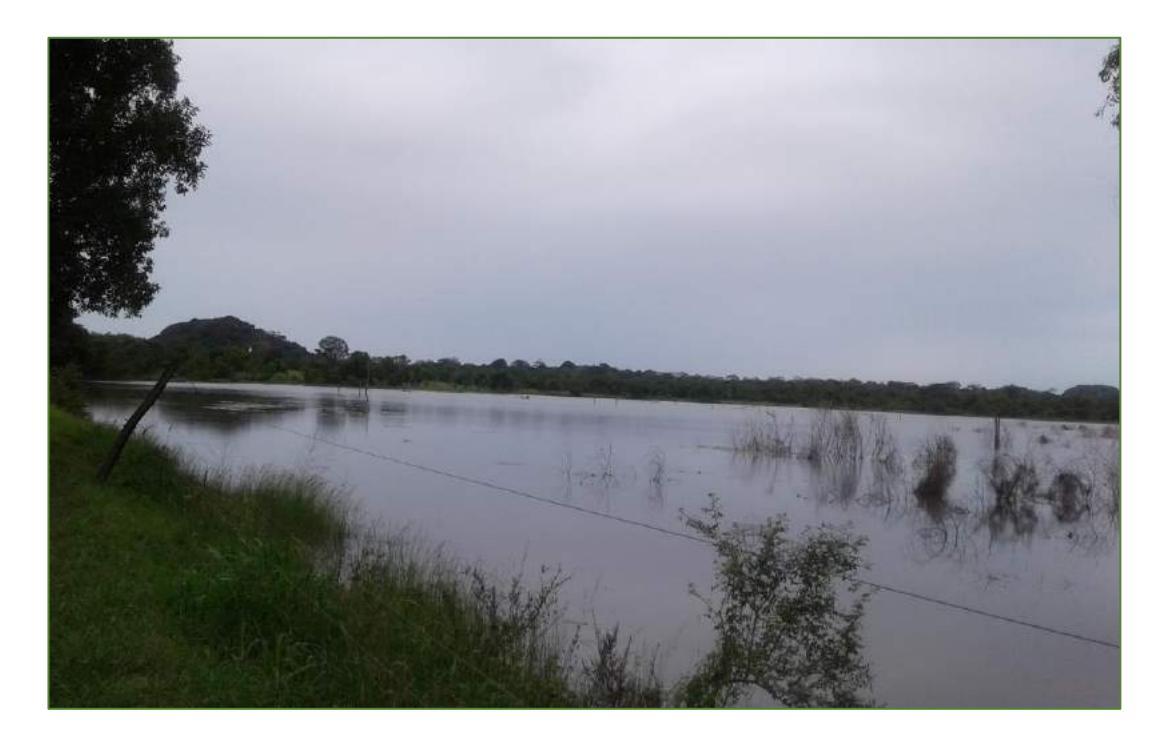
Figure 14, High flood phase (Waan Gilma/ Mattama), Pahala Ralapanawa Wewa, Ralapanawa cascade, Puttalama District,

This is the area between full supply level (FSL) and high flood level (HFL). This area is the Upstream of the tank bed. When tank spills, various floating seeds move to this area and sink in the mud when the water level depletes. Ultimately a strip of trees and bushes emerges in this area. This is called tree belt (*Gasgommana*) which acts as a windbreak and reduce the water evaporation of the tankas. The undergrowth becomes a meadow called 'filter' (*Perahana*). During the high flood phase fish species such as Shark catfish (*walaya*), Butter catfish (*Walapoththa* or *Kokussa*), and eels (Aandha) live in this habitat.

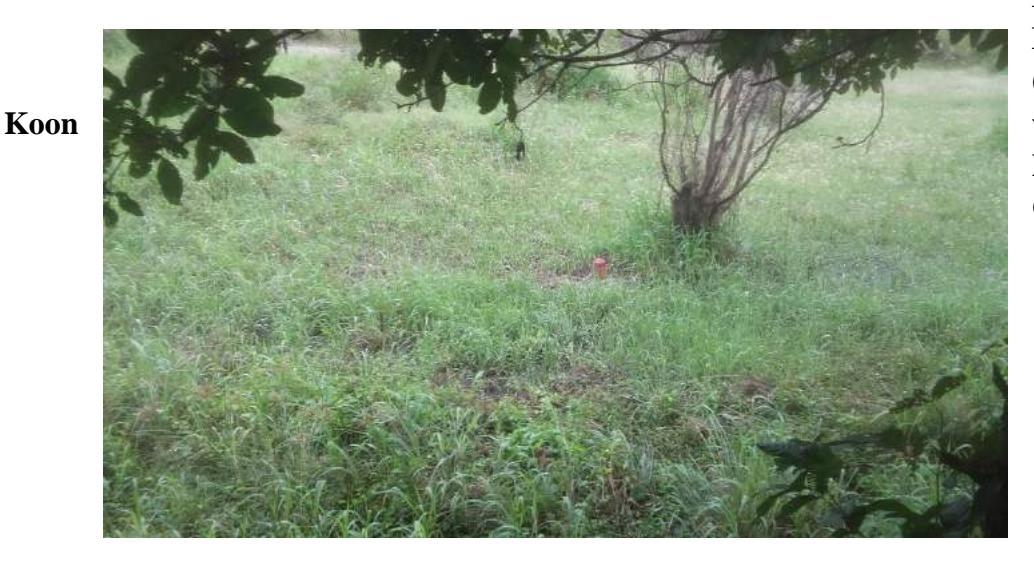
Figure 15; Filter, (Perahana), wewa, Ralapanawa Cascade

Large water-tolerant trees such as *Terminalia arjuna (Kumbuk)*, *Vitex leucoxylon (Nabada, Bauhinia racemosa (MailaSyzygium gardneri (Damba)*, and climbers such as *Phyllanthus reticulatus (Kaila)*, *Caesalpinia bonduc (Katukeliya)*, *Derris parviflora (Kalawel;)* and *Derris scandens (Bokalawel)* are found in this area. Barking deer (*Vali muva*), wild boar (*Wal oora*), sambur (Gona), wild buffalo (Mee haraka) are also found here, and elephants also roam in this area. The filter or *Perahana* is the meadow developed under the tree belt which filters the sediment which flow from upstream chena lands.

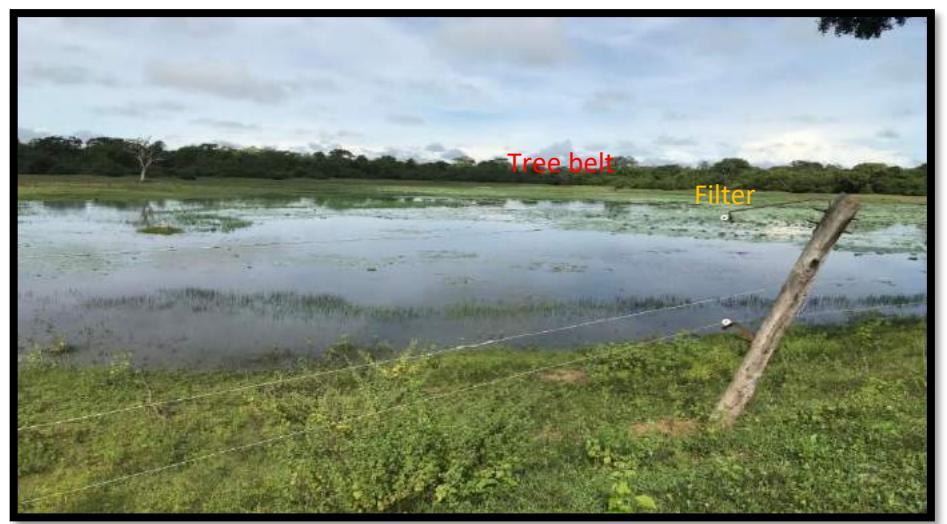
Figure 16, Gasgommana (Tree Belt) and Perahana (Filter) of Kadapaslapu Wewa

The tree belt, buffer zone for winds called *Gasgommana* possesses a naturally grown vegetation in the upstream land strip (*Waan gilma*) above the tank bed, accommodating water when it spills. The tree belt acts as a wind barrier reducing evaporation from the tank and lowering the water temperature. The roots of large trees make water cages on either side of the bund, creating breeding and living spaces for some fish species. This strip of trees demarcates the territory between humans and wild animals.

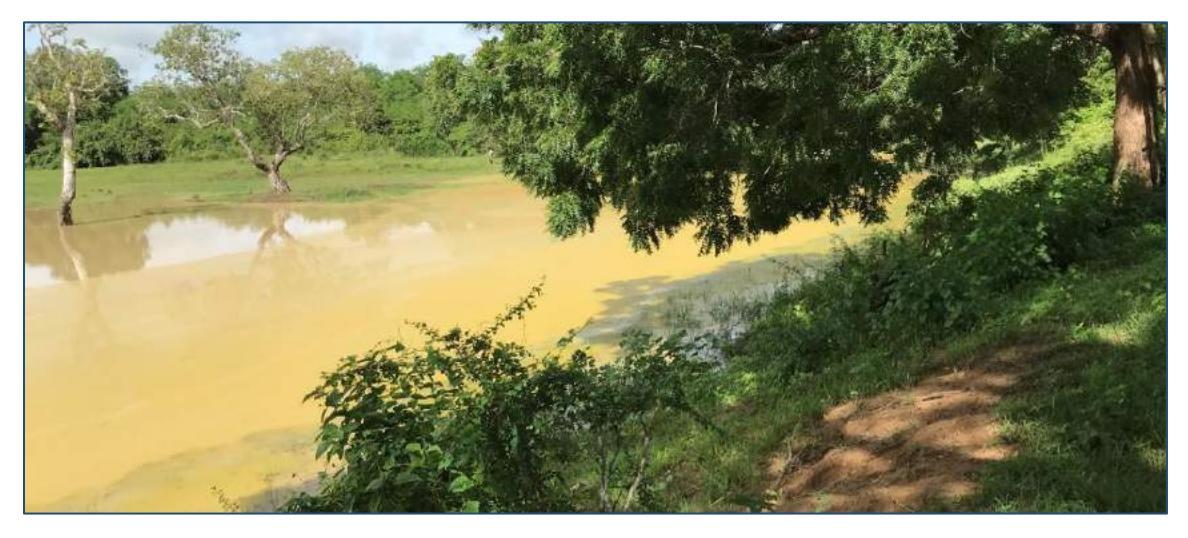
Figure 17; An Olagam tank with damaged filter and Iswetiya of Ihala Wewa in Rambawewa Cascade in Karuwalagaswewa DSD

Upstream earth ridges to prevent sediment inflow is called *Iswetiya*. Tanks are generally constructed at a confluence of the stream network to reduce the bund length. For the same reason, the land slope of both sides of the upstream area is relatively high. There is, therefore, a risk of sediment inflow from these areas into the tank. In the past, soil ridges known as *Iswetiya* or *Pota Wetiya* were constructed to minimize this sediment inflow. In present tank systems, *Isweti* are hard to be found. The importance of having this structure is evident as many tanks have been heavily silted up because of the absence of *Perahana, Godawala, and Iswetiya*.

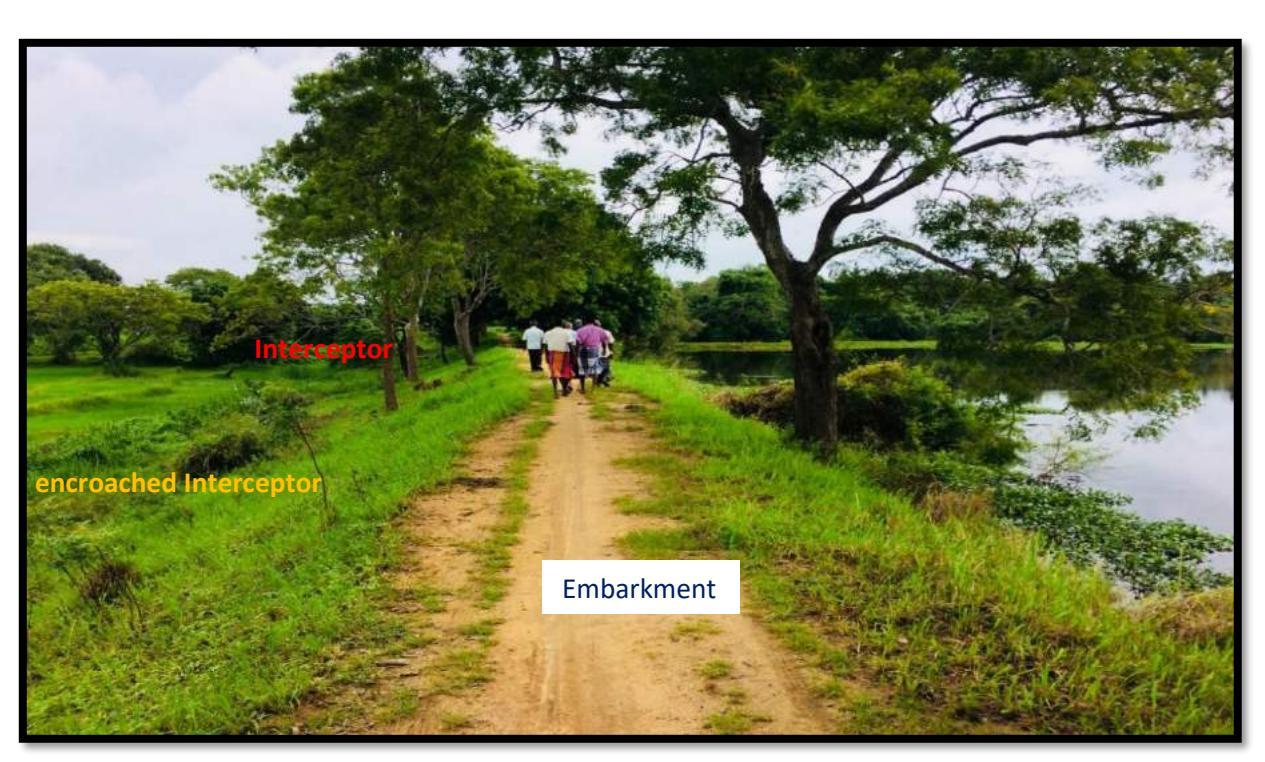
Figure 18, Tank Embarkment, (Wew Bemma), and Interceptor (Kattakaduwa) Location:

Wetiya wewa cascade, Katapaththa wewa, Puttalam District

Note: Part of the interceptor has been encroached by the farmers in this tank

And therefore, diverse vegetation is developed. The interceptor forest is a natural bio-filter that traps impurities such as salts and metal ions in the water before it irrigates in to the low-lying Paddy tracts. The thick root system of trees and shrubs act as a protective cushion for the sloping land. Well-developed interceptor forests provide convenient resting sites for birds, bats, reptiles, and amphibians.
